Anchorage capacity of naturally corroded reinforcement in an existing bridge

Berg, F., Johansson, D., Lundgren, K. et al (2012). Anchorage capacity of naturally corroded reinforcement in an existing bridge. Proceedings of the Sixth International Conference on Bridge Maintenance, Safety and Management, IABMAS 2012, Stresa, Lake Maggiore, 8-12 July 2012: 2800-2807. <http://dx.doi.org/10.1201/b12352-428>

F. Berg & D. Johansson

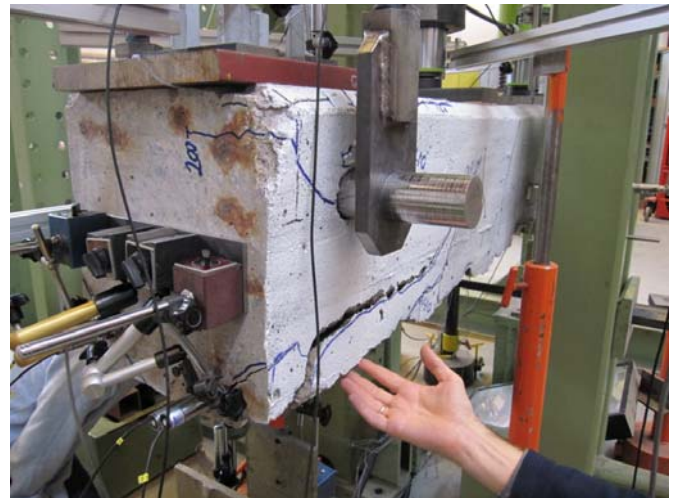
Figure 10. Third test specimen (high corrosion with cover spalling) at failure.

Figure 8 shows the average load versus the free end slip in the second test (with low corrosion). The corresponding result in the test with high corrosion degree is similar. As can be seen in Figure 8, all the main bars had a considerable slip of 0.1 mm in the pre-peak stage, which indicates that anchorage failure took place. Photos showing the crack patterns can be found in Figures 9 and 10.
